## TECHNICAL SAFETY BC JURISDICTION AND ROLE

Technical Safety BC conducted a thorough investigation into the ammonia-release incident at Fernie Memorial Arena on October 17, 2017 to determine cause and provide recommendations to improve refrigeration system safety. Findings and recommendations are included in Technical Safety BC's Investigation Report, released July 25, 2018.

## INVESTIGATION DETAILS

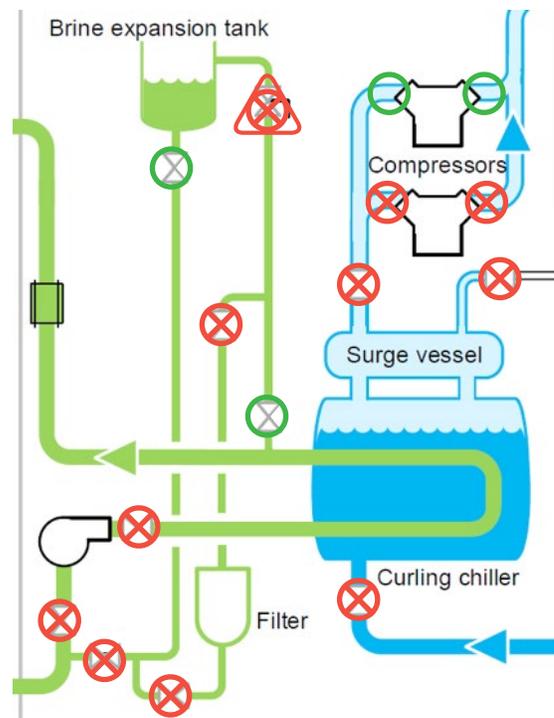
**Diagram:** Valve positions found resulted with liquid ammonia contained in the leaking chiller and no pressure relief in the brine system.

During seasonal maintenance, ammonia was detected in the curling brine system, indicating a leak. The Technical Safety BC investigation later found that ammonia had leaked into the brine through a small 2.2mm by 0.2mm hole in a tube within the curling system chiller (\* in diagram).

Ammonia alarm in the arena's mechanical room triggered. The brine system and curling chiller are isolated and the refrigeration and brine system shut down (at points marked X). Shut-down configuration isolated liquid ammonia within the chiller and isolated the brine system so that expansion and ventilation of brine was impeded. Ammonia continues to leak into the brine. Ammonia concentration increases in the brine. Brine and chiller temperature rise, leading to elevated pressure within the brine system and chiller.

Rising pressure within the brine system eventually exceeds the strength of a pipe joint and a coupling separates within the mechanical room. The coupling's separation suddenly depressurizes the brine system and causes ammonia in the brine and piping to rapidly release into the mechanical room. As ammonia releases, it quickly expands in the room, reaching estimated concentrations above levels that are considered to be rapidly fatal.

1 The equipment failure was caused by a small hole in the curling chiller carbon steel tube resulting from corrosion at a weld seam. Contributing to this failure and the release of ammonia was the:
