## Appendix I: Spray Residue Analysis

Samples of residue sprayed on the walls and ceiling of the mechanical room were collected for chemical composition analysis.

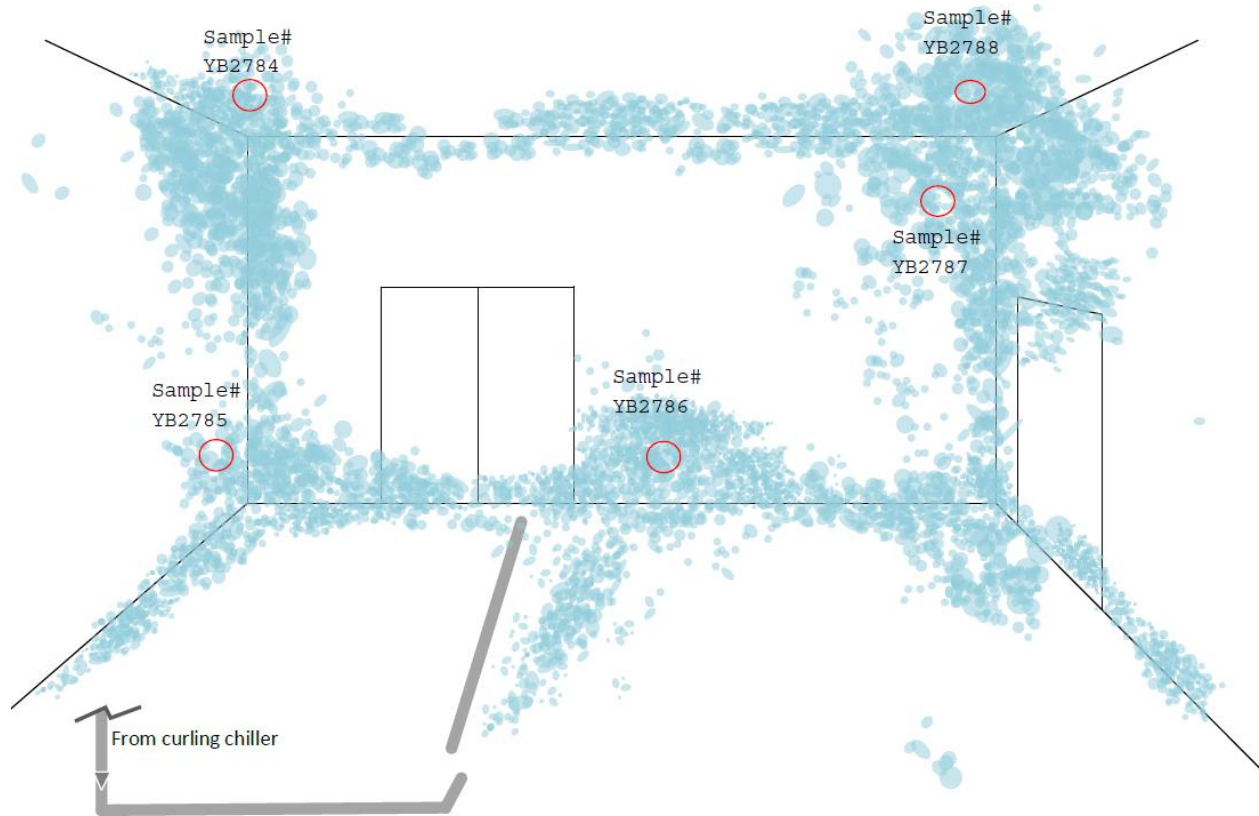
**Figure I-1:** Map of residue samples collected by Technical Safety BC

Technical Safety BC scraped residue off vertical wall surfaces from three locations and a one-inch outer layer of finished drywall was taken from two ceiling locations. The locations are labeled in Figure I-1.

Laboratory results provided a chemical analysis of the composition of solids found on the mechanical room's surfaces (attached). The ratio of calcium to chloride found in 3 wall residue samples is consistent with a calcium chloride solution source. The 2 ceiling samples indicated elevated levels of calcium.

Laboratory analysis indicate the residue samples from the walls likely contained calcium chloride. Calcium chloride is a chemical compound that is not typically found in the wall materials (i.e., paint). Calcium chloride was used in the Fernie Memorial Arena's secondary coolant (brine) system. It is likely the residue on the mechanical room wall surfaces was the brine solution.

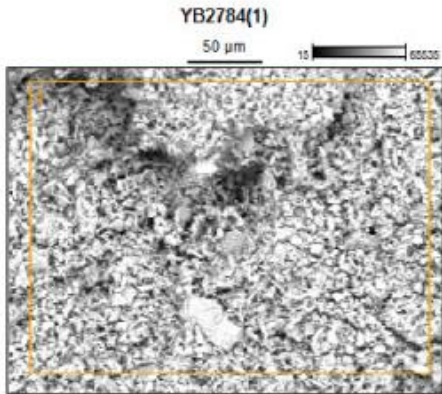
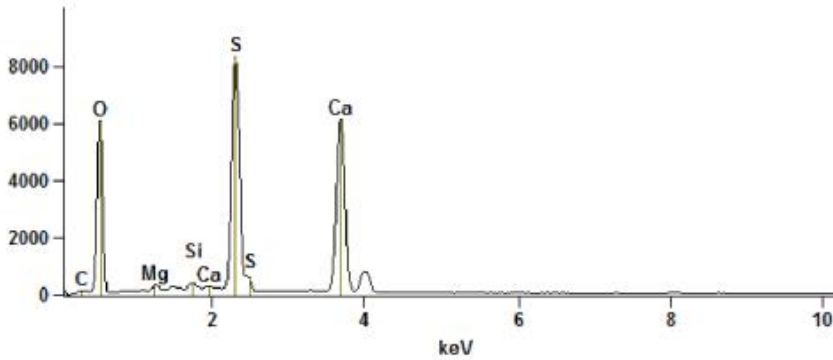
**As Figure 1 shows the residue on Outer Layer of Gyprock Ceiling is made of:**

**Oxygen: 49%**  
**Calcium: 28%**  
**Sulphur: 22%**  
**Silicon: 0.3%**  
**Magnesium: 0.2%**

**Suspect Calcium Sulphate or Calcium Sulphite or unknown compound of Calcium, Sulphur and Oxygen.**

**Please find the source of Sulphur.**

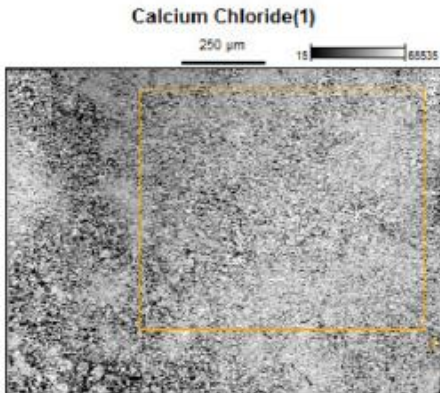
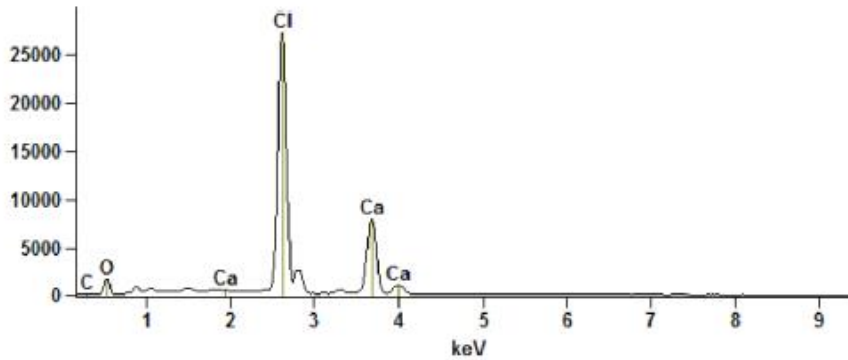
Figure 2  
Calcium Chloride

Note: Figure 2 for Location (1), Sample #: YB2784 provides an analysis of a sample taken from a bag labeled “Anhydrous Calcium Chloride 94-97% Mini-Pellets” located in the Fernie arena mechanical room.

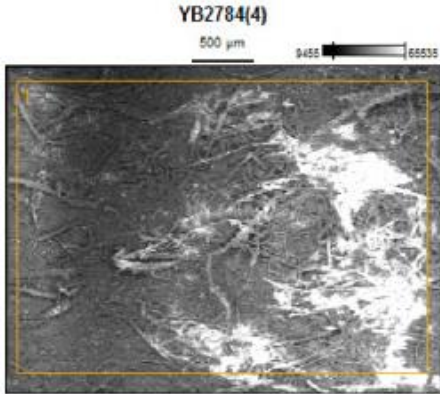
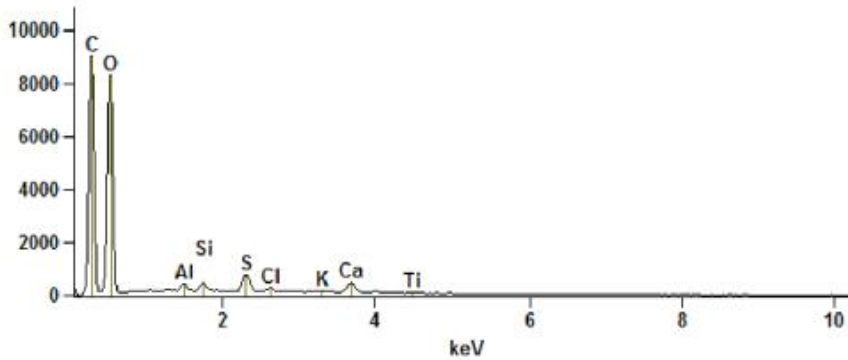
Figure 3  
Composition of  
drywall

**For reference Figure 2 shows Calcium Chloride and Figure 3 shows Dry wall composition which is mostly Carbon and Oxygen.**

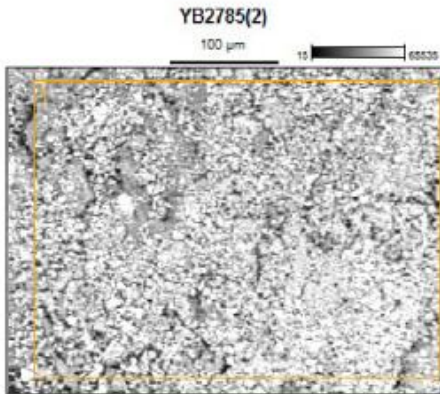
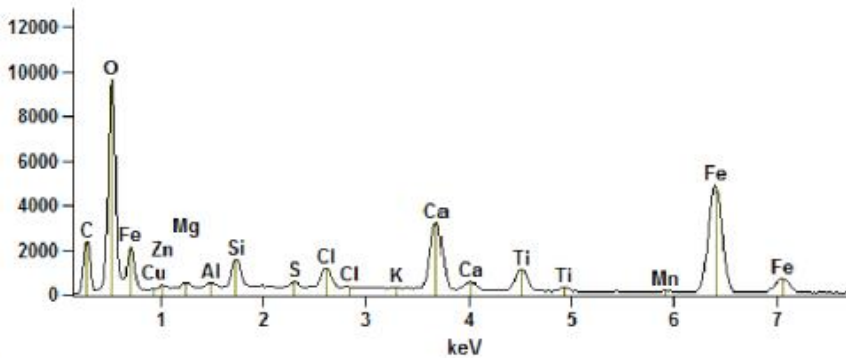
**Figure 1 shows composition of solids scraped off painted cement.**

**As Figure 1 and 2 show the solids are made of Iron Oxide, paint, Calcium, Calcium Chloride (suspect), Carbon (Suspect wall), trace amount of Aluminum, Manganese, Copper, Silicon and Magnesium.**

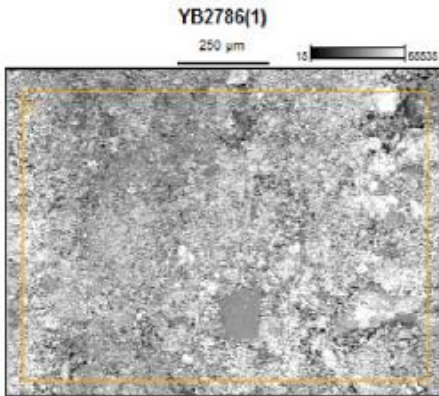
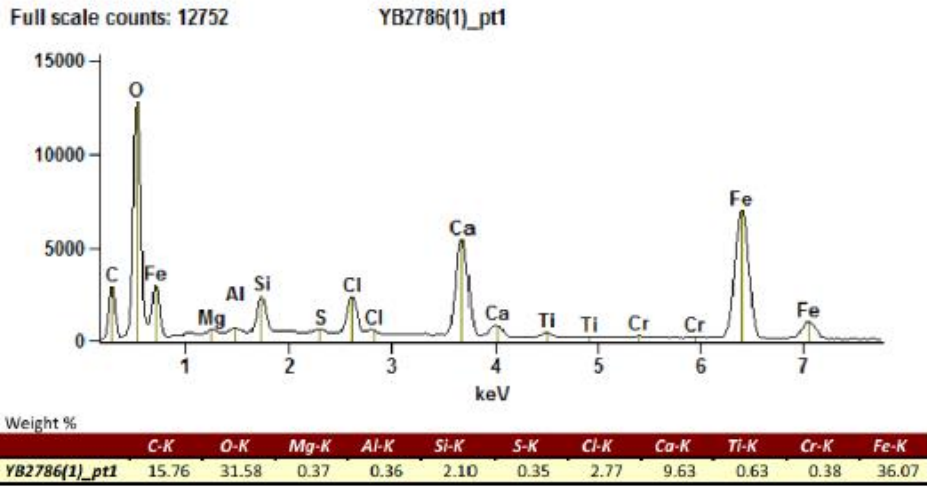
**Figure 1 shows composition of solids scraped off painted cement.**

**As Figure 1 show the solids are made of Iron Oxide, paint, Calcium, Calcium Chloride (suspect), Carbon (Suspect wall), trace amount of Aluminum, Silicon and Magnesium.**

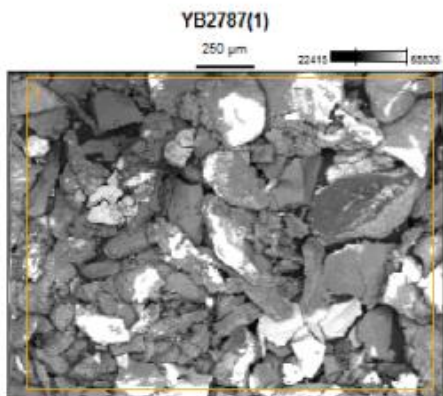
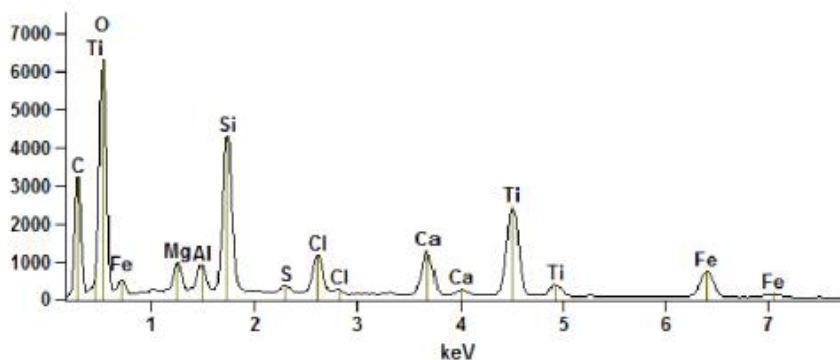
**Figure 1 shows composition of solids scraped off painted cement.**

**As Figure 1 show the solids are made of Iron Oxide, paint, Sands, Carbon (Suspect wall), trace amount of Calcium, Calcium Chloride (suspect), Aluminum, Magnesium.**

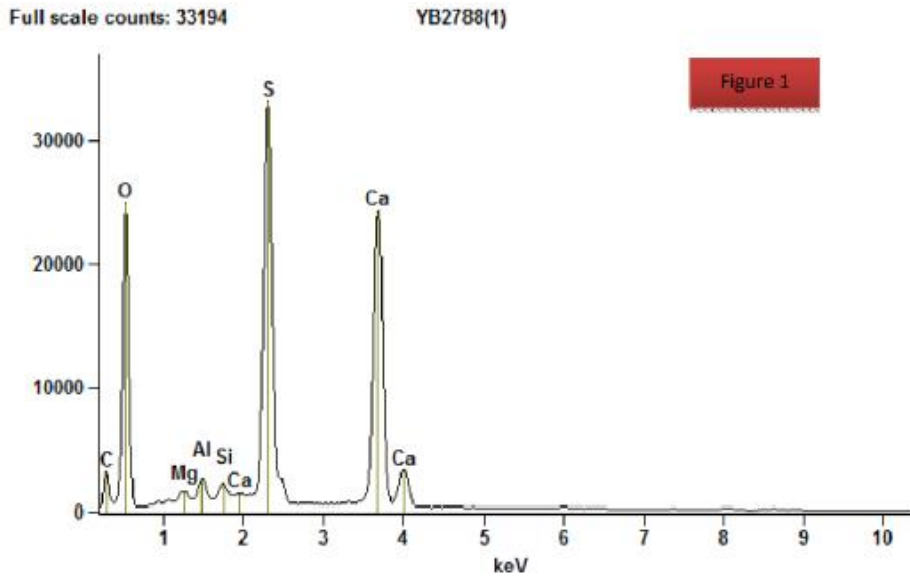
Quantitative Results for: YB2788(1)

**As Figure 1 shows the residue on Outer Layer of Gyprock Ceiling is made of:**

**Suspect Calcium Sulphate or Calcium Sulphite or unknown compound of Calcium, Sulphur/Oxygen.**
